QUALIFICATION TESTING OF REDESIGNED F-15/F-4 600 GALLON 1/1

Report No. 86-R-06
AFPEA Project No. 85-P-129

QUALIFICATION TESTING OF REDESIGNED
F-15/F-4 600 GALLON BI-PAC
FUEL TANK CONTAINER

HQ AFLC/DSTZ
AIR FORCE PACKAGING EVALUATION AGENCY
Wright-Patterson AFB OH 45433-5999

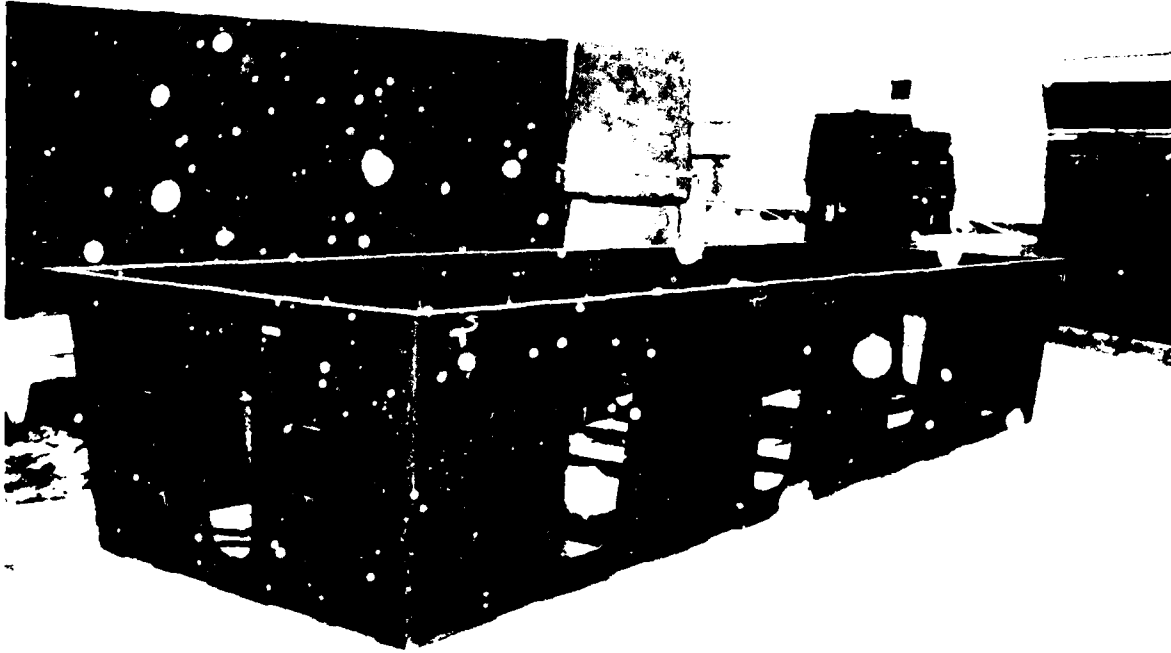
Figure 1. F-4/F-15 600 Gallon Fuel Tank Bi-Pac Container (NSN 8145-01-02509738).

TEST SPECIMENS: Simulated transportation and handling tests were performed on two F-15/F-4 600 Gallon Bi-Pac Fuel Tank Containers as requested by WR-ALC/MMT/DSTD (see figure 1). The tests were performed at the Air Force Packaging Evaluation Agency and the 3246 Test Wing, Eglin AFB FL, on containers Serial No (S/N) 001 and 002 between 17 Dec 85 and 31 Jan 86. Physical and general information on both containers was recorded as follows:

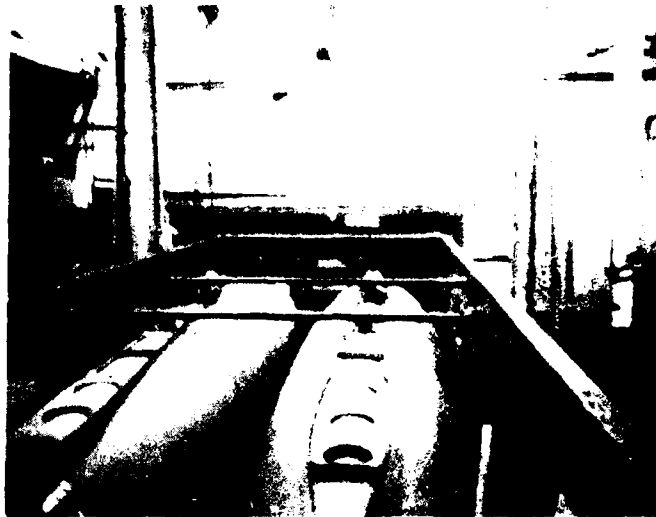
Figure 3. F-4 600 Gallon High
Performance Fuel
Tanks stowed in
Bi-Pac Container.

Container S/N 002 - 1399 pounds when loaded with two F-4 high performance (HP) Configuration External Fuel Tanks (see figure 3).

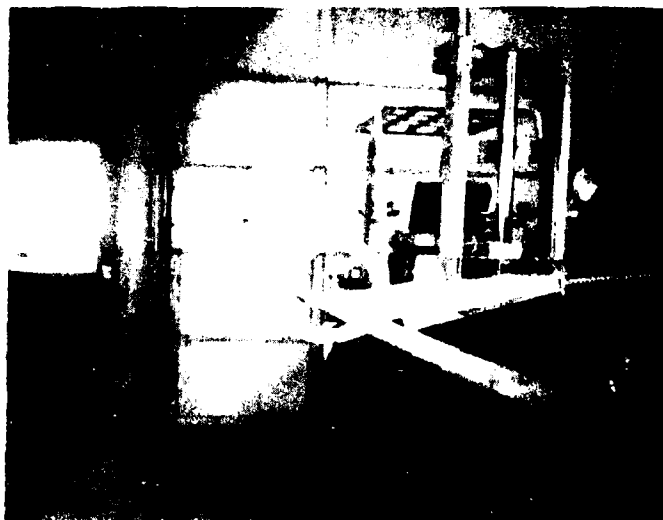
Figure 6. Container S/N 002 on vibration table.

Test No. 4A: The vibration test was conducted in accordance with FTMS No. 101C, Method 5019.1. The test container (S/N 002) was loaded with two F-4 HP fuel tanks (see figure 6).

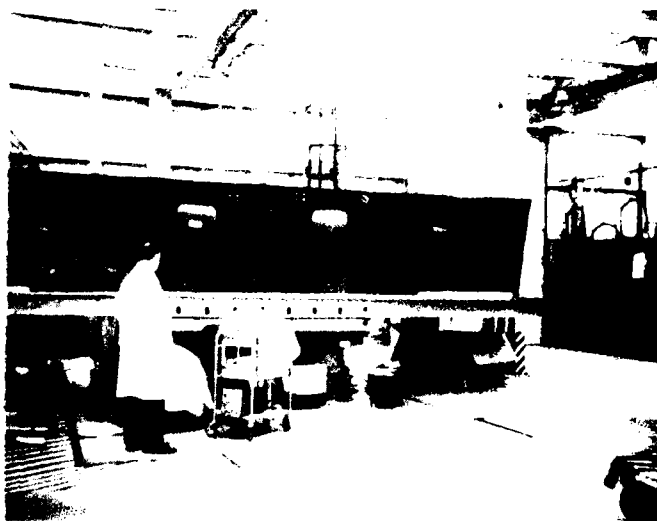
Figure 7. Containers S/N 001 and S/N 002 on vibration table, stacked two high.

Test No. 4B: The vibration test was conducted in accordance with FTMS No. 101C, Method 5019.1. The containers were vibrated stacked two high (see figure 7). Container (S/N 001) loaded with two STD F-4 fuel tanks was the the bottom container. Container

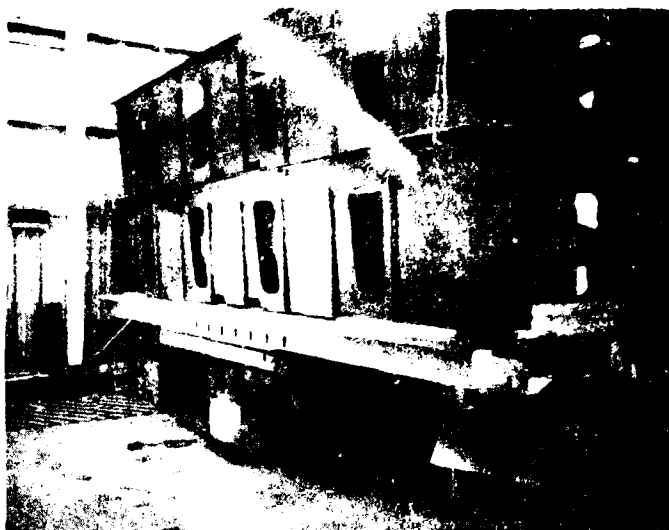
Results: 1. The tabs on container (S/N 001) restraint bar received minor wear and were bent during this vibration sequence. The tabs on container (S/N 002) restraint bar received additional wear and were bent further during this vibration sequence (see figure 8 & 9).

Figure 8. Container S/N 002. Deformation of restraint bar tabs after vibration test, stacked two high.

1. A second set of quick release pin holes should be drilled in each stacking board so that the quick release pins can be secured when the stacking boards are in the stowed position (see attachment 2).
2. A twelve inch high physical restraint is required to prevent overnesting of the containers.
3. An adhesive such as "loctite" should be applied to the lanyard attachment screws to ensure that they do not loosen and eventually back out.
4. The two lanyards which attach the restraint bars to the container should be eliminated (ACT Drawing No. 809074 Assy, Bi-Pac Container Item No. 15).
5. The restraint bar tab thickness should be changed from 0.120 to 0.188 inches. The 0.120 inch restraint bar tabs deformed

during vibration and pendulum impact testing. Under the same test conditions, previous testing has shown that a 0.188 inch thick restraint bar tab does not deform.

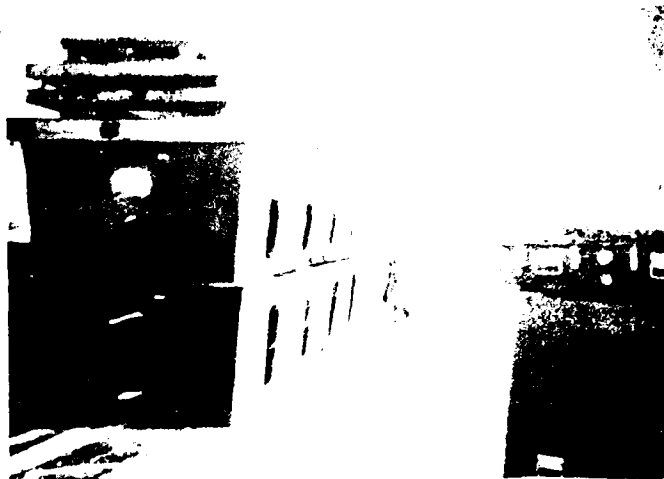
Results: The stacking boards on the bottom container (S/N 002) deflected and lifted off the sides of the container 1/8 to 1/4 inch. There was a bow of 1/4 inch at each of the four corner panels on the 272 inch sides of both containers. These deflections were not permanent and disappeared when the weights were removed from the containers at the end of the test. The results of this test were acceptable.

Figure 14. Superimposed load test
side view.
